S/015/051

DOGAL REC.
7/31/96

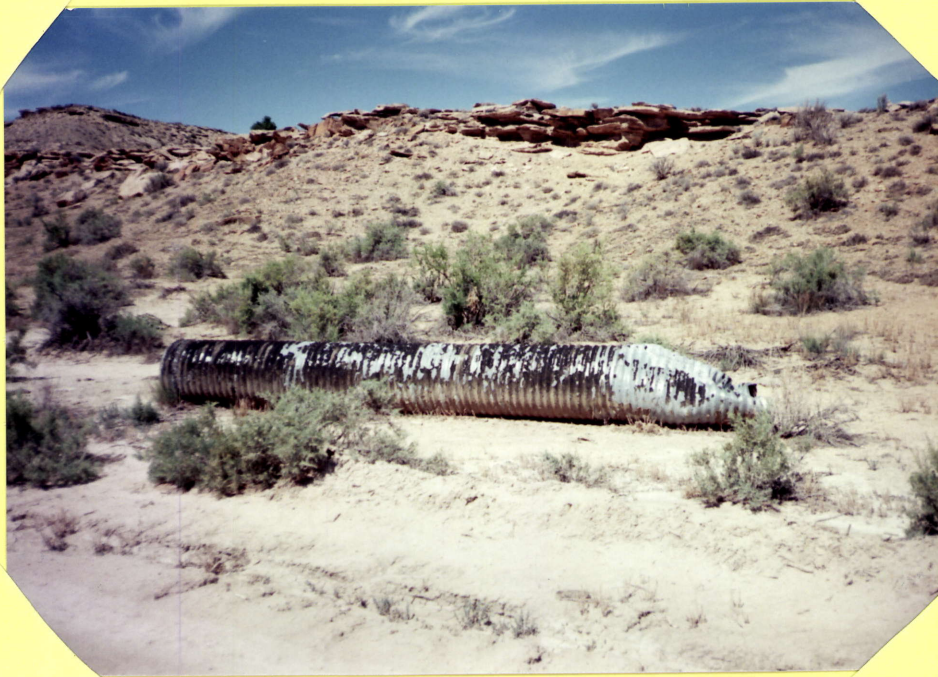
A. Culvert adjacent ot the access road in T.21S., R.7E., Section 34, Ron Wright, notice UTU-68020. 7-23-96..

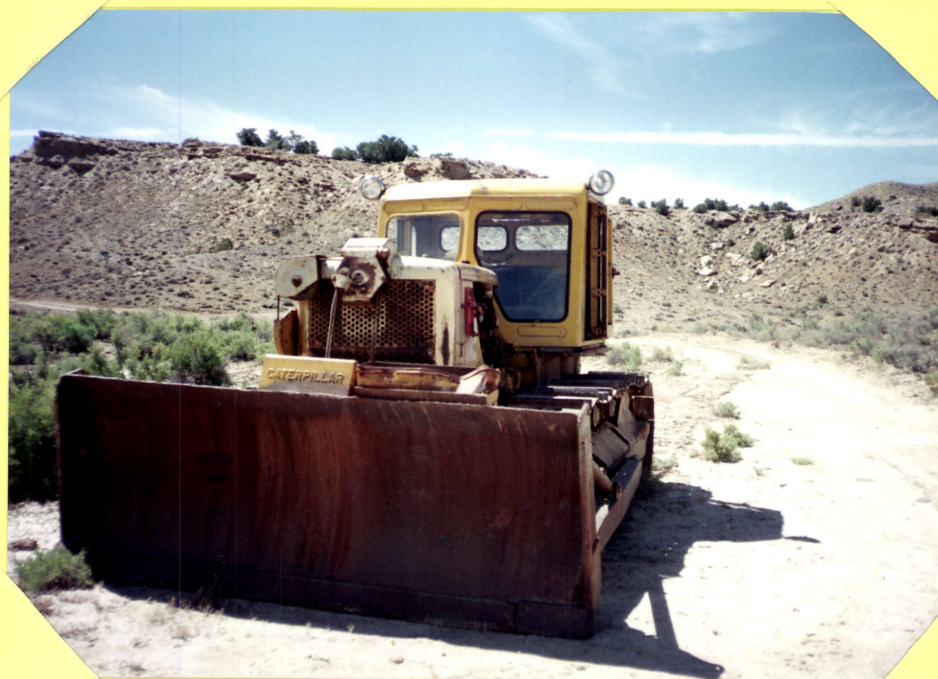
B. Bulldozer parked adjacent to the access road across from the culvert in T.21S., R.7E., Section 34, Ron Wright, notice UTU-68020. 7-23-96..

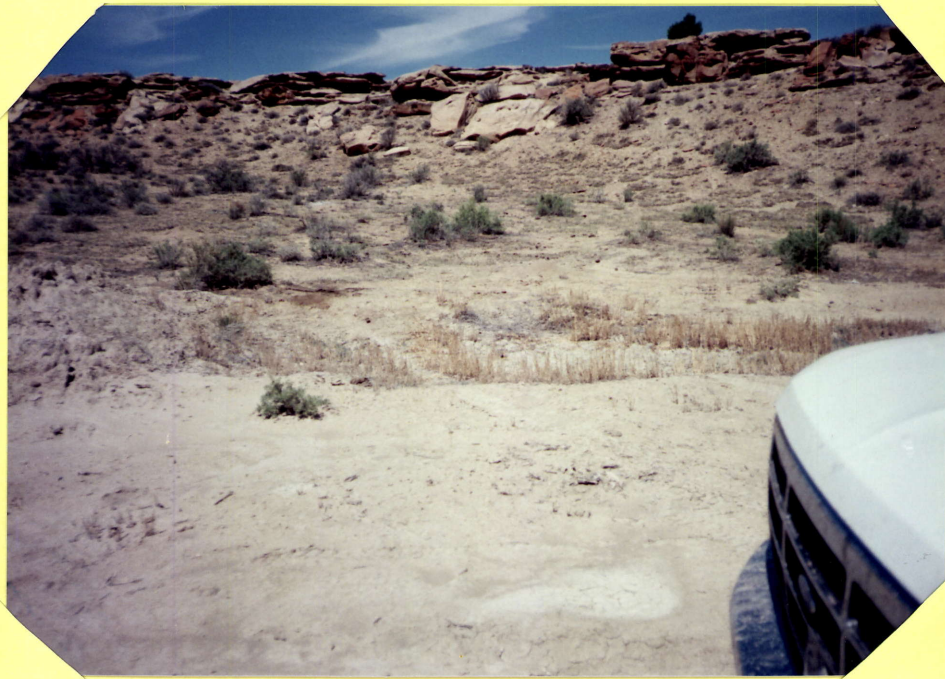
C. Area adjacent to the access road from which junk has been removed in T.21S., R.7E., Section 34, notice UTU-68020, Ron Wright. 7-23-96.

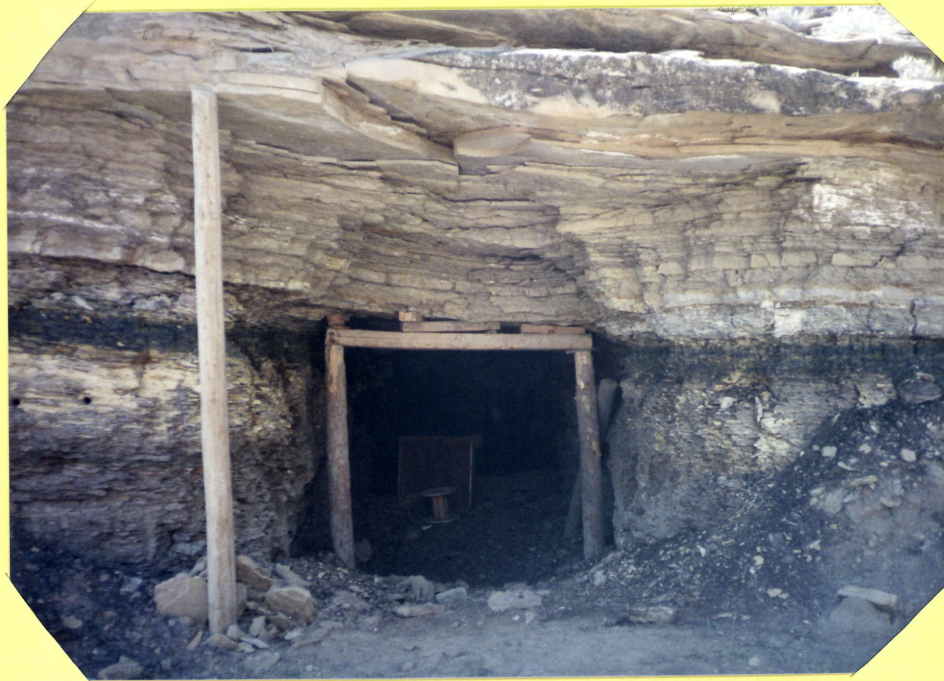
D. Portal to the mine in T.21S., R.7E., Section 34, Ron Wright, notice UTU-68020. 7-23-96.

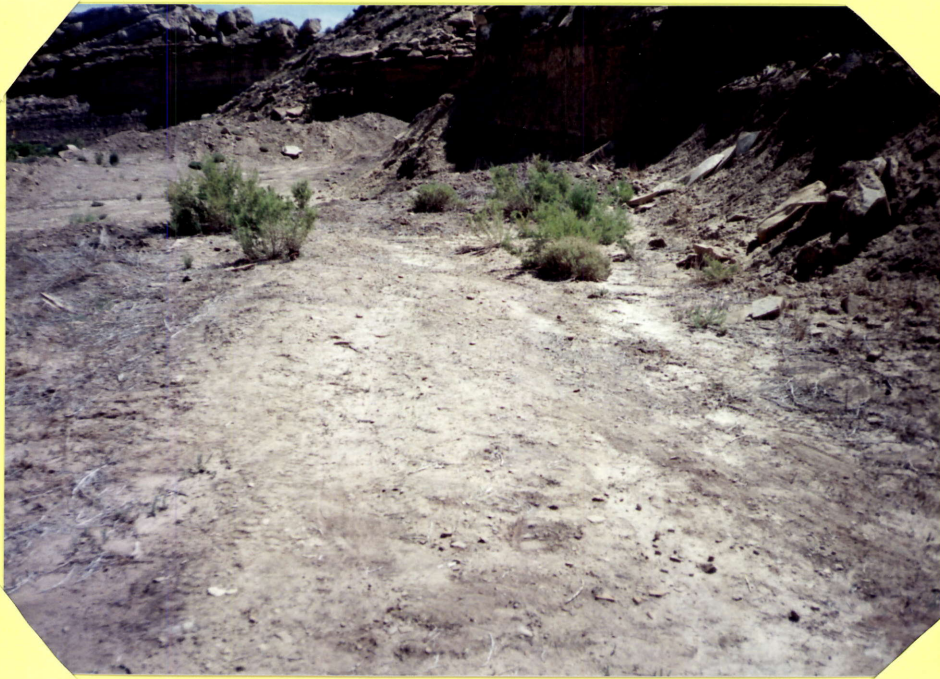
E. Area just north of the portal from which junk has been removed in T.21S., R.7E., Section 34, Ron Wright, notice UTU-68020. 7-23-96.

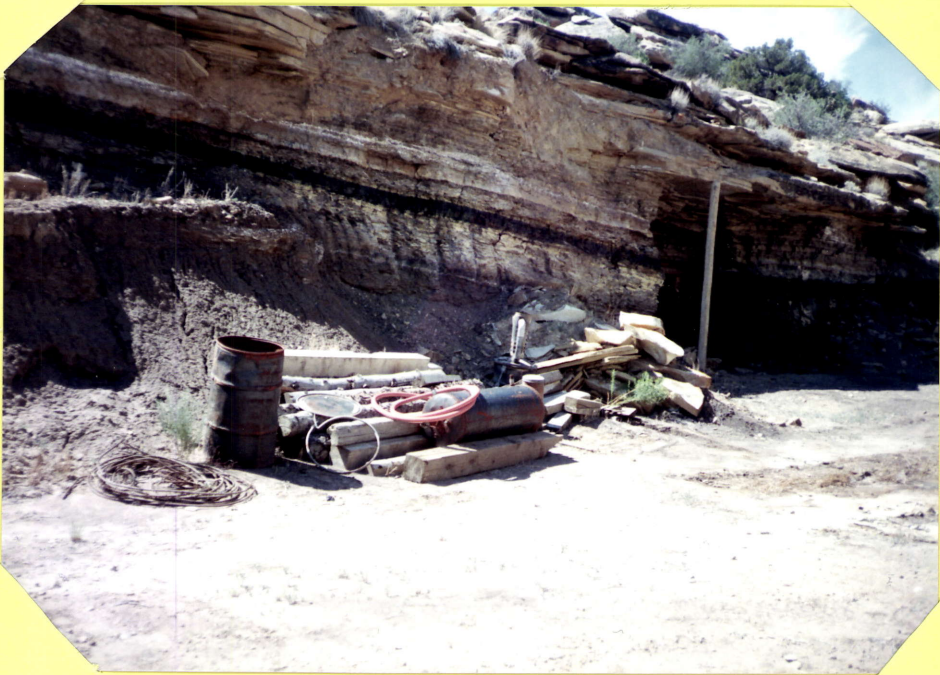
F. Materials stacked neatly against the cliff face and north of the portal in T.21S., R.7E., Section 34, Ron Wright, notice UTU-68020. 7-23-96.

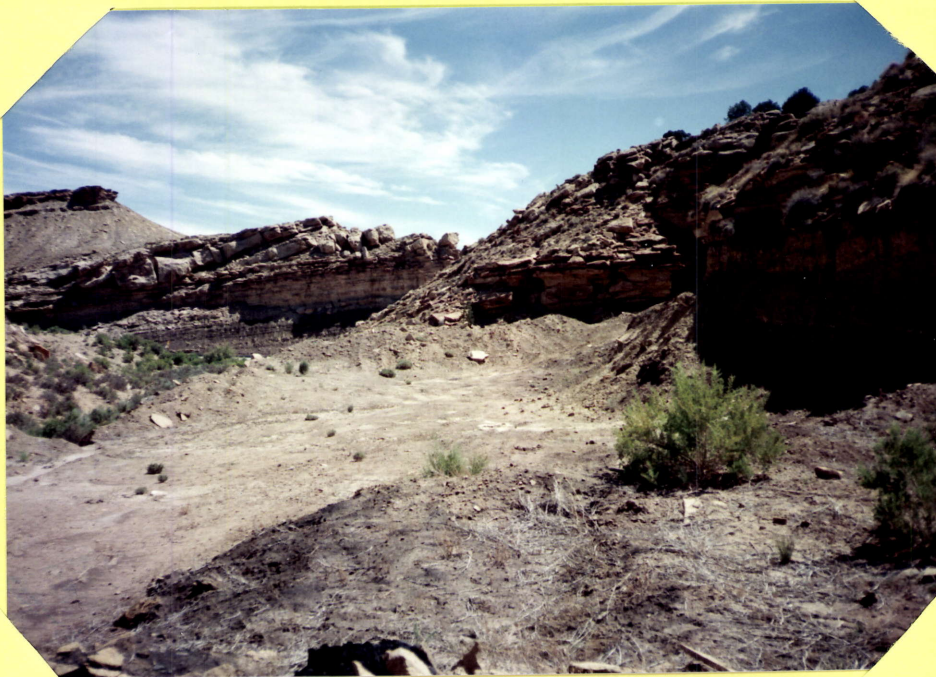
H. Area of operations north of the portal In T.21S., R.7E., Section 34, Ron Wright, notice UTU-68020. 7-23-96.

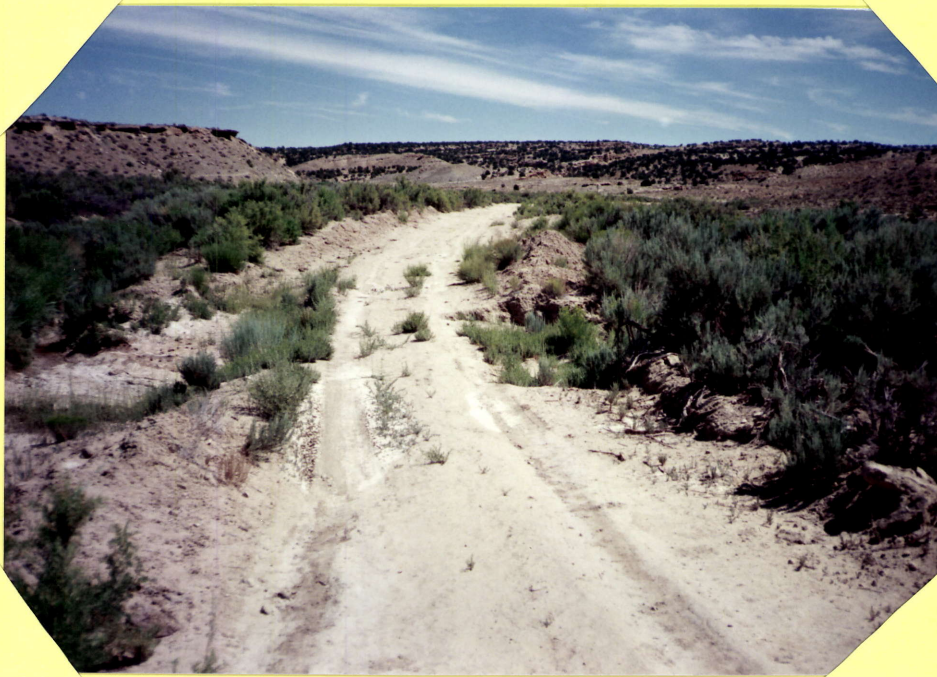
- I. Erosion on the access road where it crosses the wash just south of the county road in T21S., R.7E., Section 34, Ron Wright, notice UTU-68020. 7-23-96.

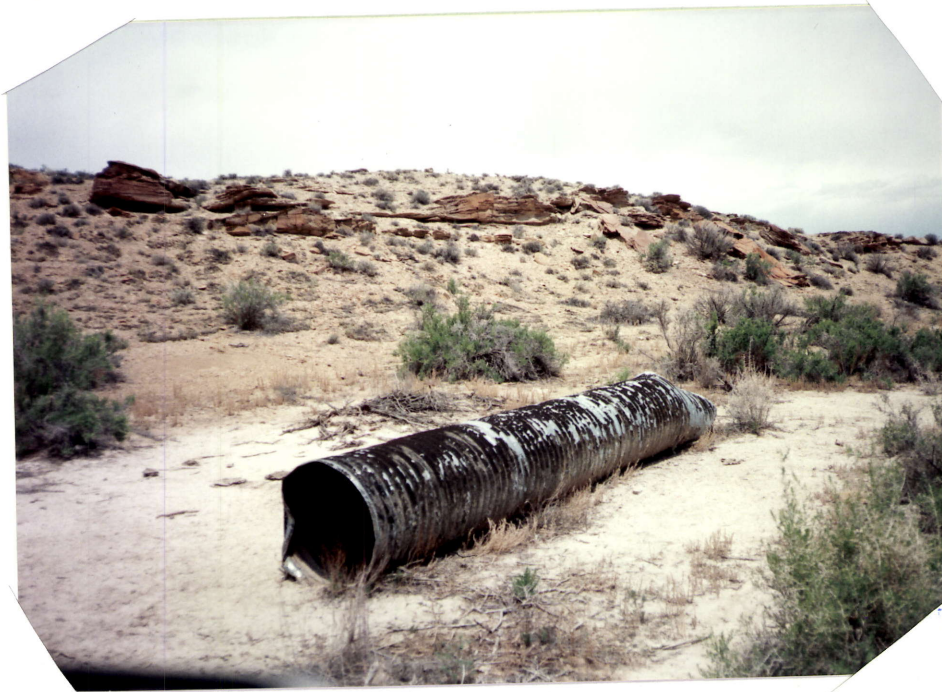
A. Culvert along access road, Ron Wright, notice UTU-68020 in T.21S., R.7E., Section 34. 5-30-96.

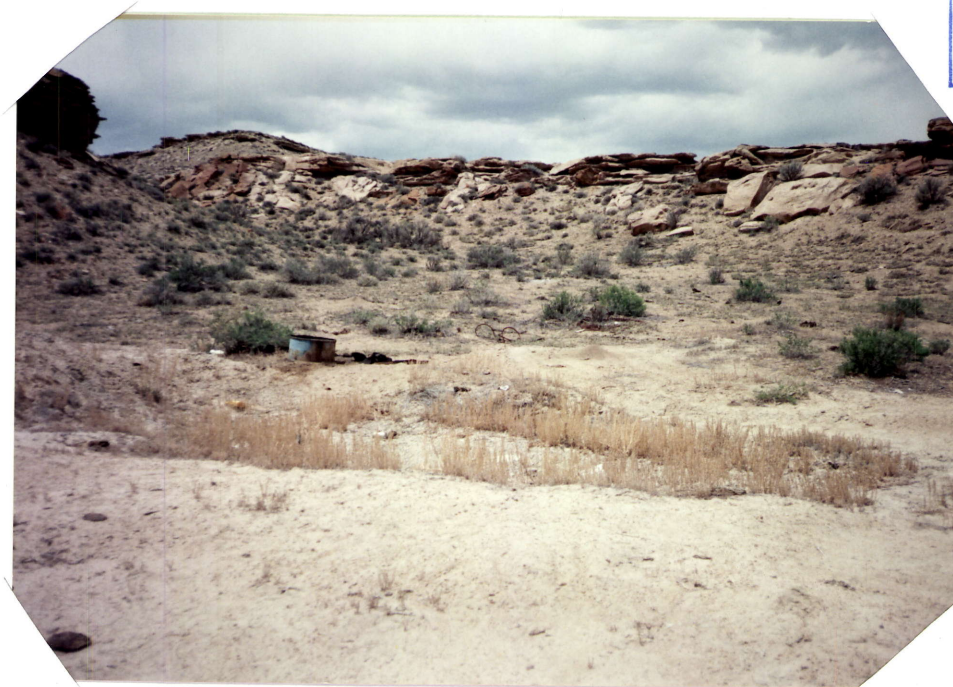
B. Junk beside the access road, Ron Wright, notice UTU-68020 in T.21S., R.7E., Section 34.

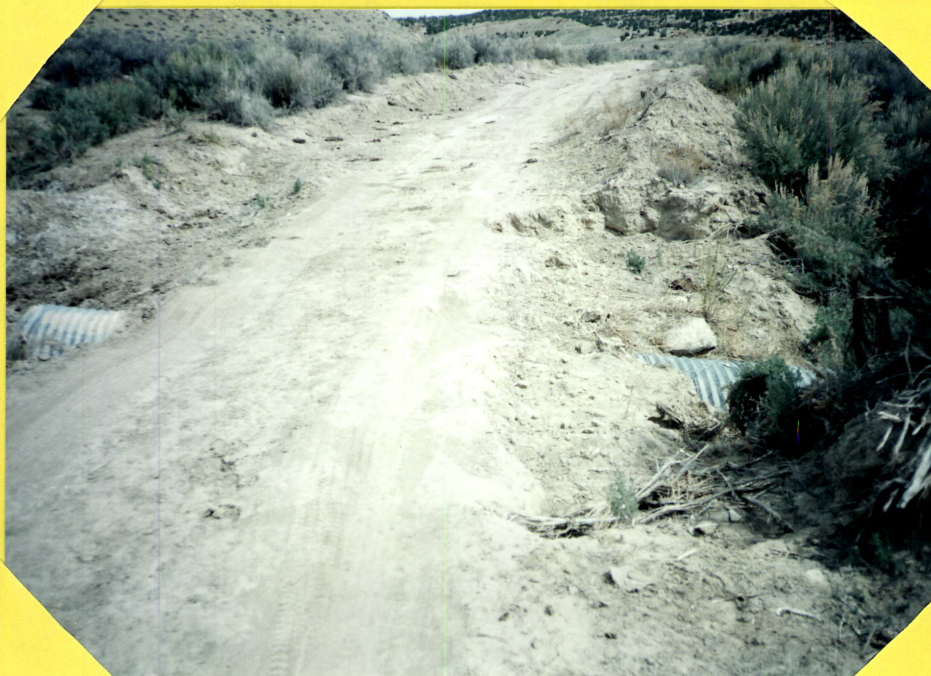
A. Erosion around the culvert in the wash near the county road, Ron Wright, Notice UTU-68020 in T.21S., R.7E., Section 34. 4-16-96.

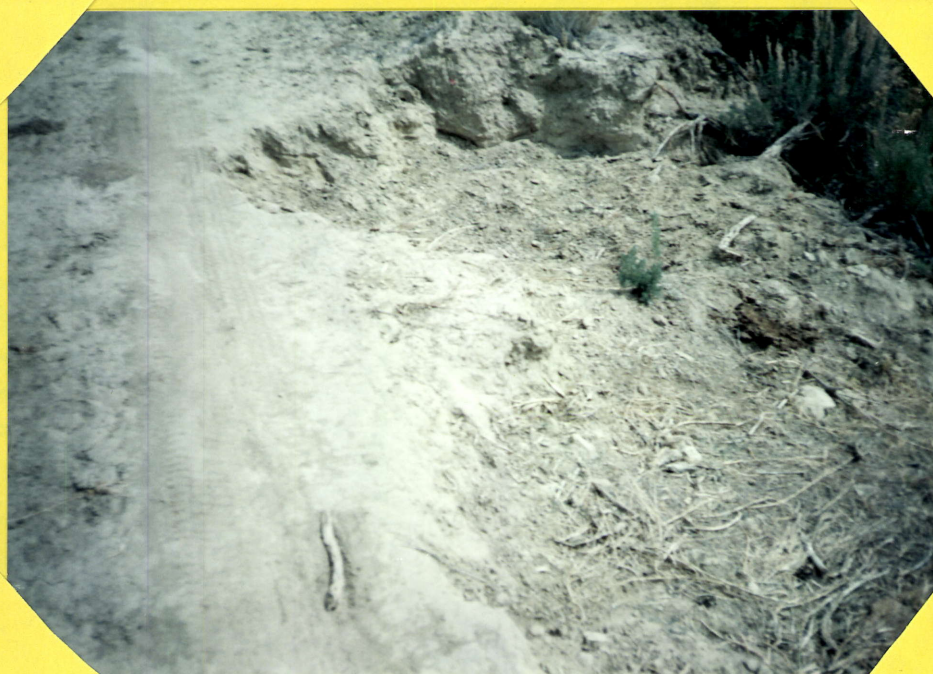
B. Closeup of the erosion on the access road, Ron Wright, notice UTU-68020 in T.21S., R.7E., Section 34. 4-16-96.

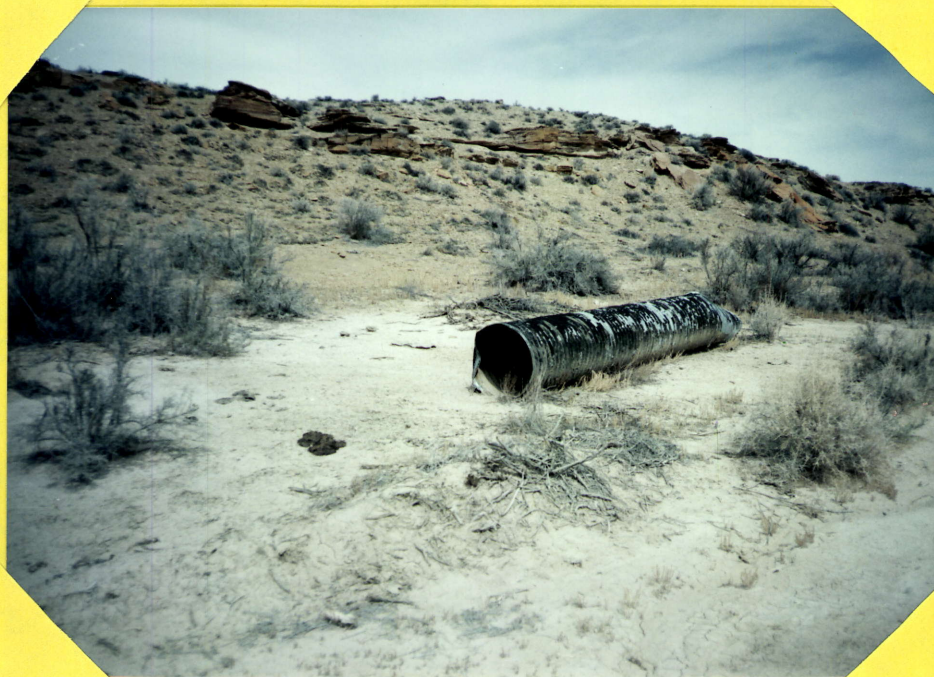
C. Abandoned culvert along the access road to the Reefer mine, Ron Wright, notice UTU-68020 in T.21S., R.7E., Section 34. 4-16-96.

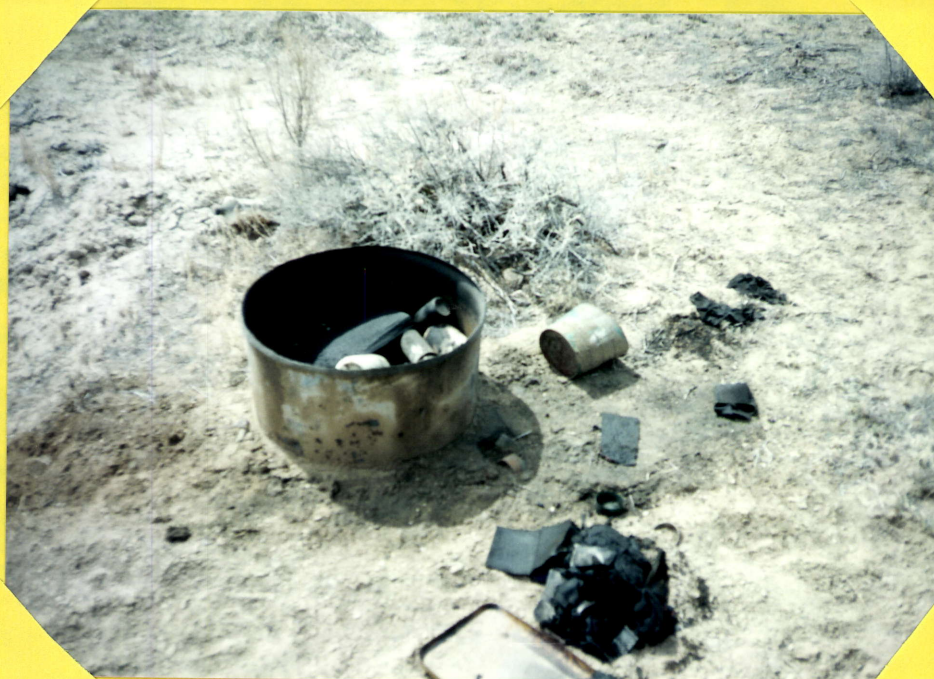
D. Junk along the side of the access road, Ron Wright, notice UTU-68020 in T.21S., R.7E., Section 34. 4-16-96.

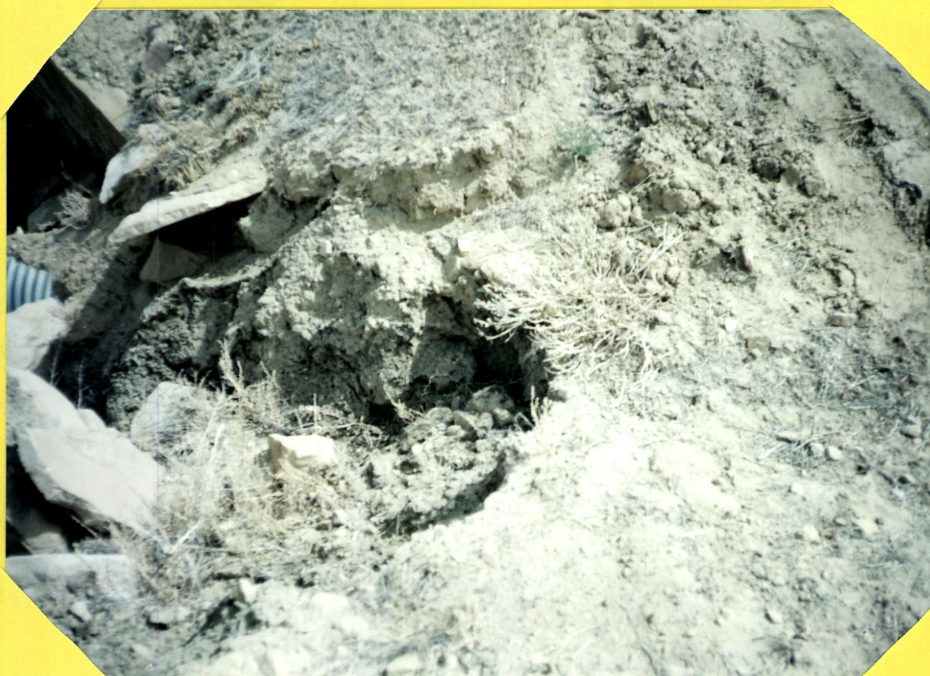
- E. Erosion occurring near the second culvert installed in the canyon, Ron Wright, notice UTU-68020 in T.21S., R.7E., Section 34. 4-16-96.

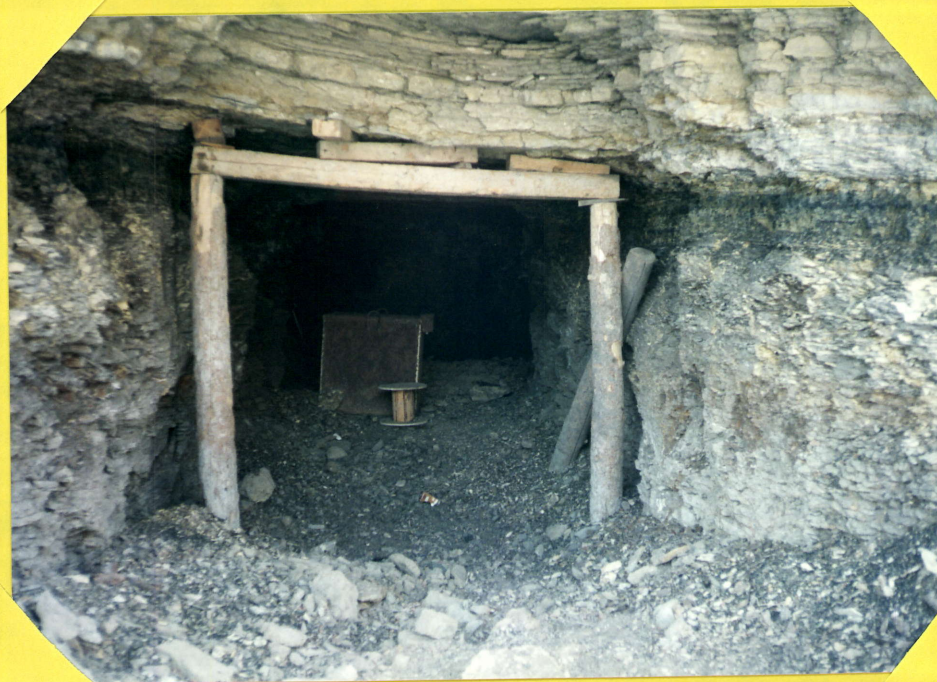
- F. Reefer mine portal, Ron Wright, notice UTU-68020 in T.21S., R.7E., Section 34. 4-16-96.

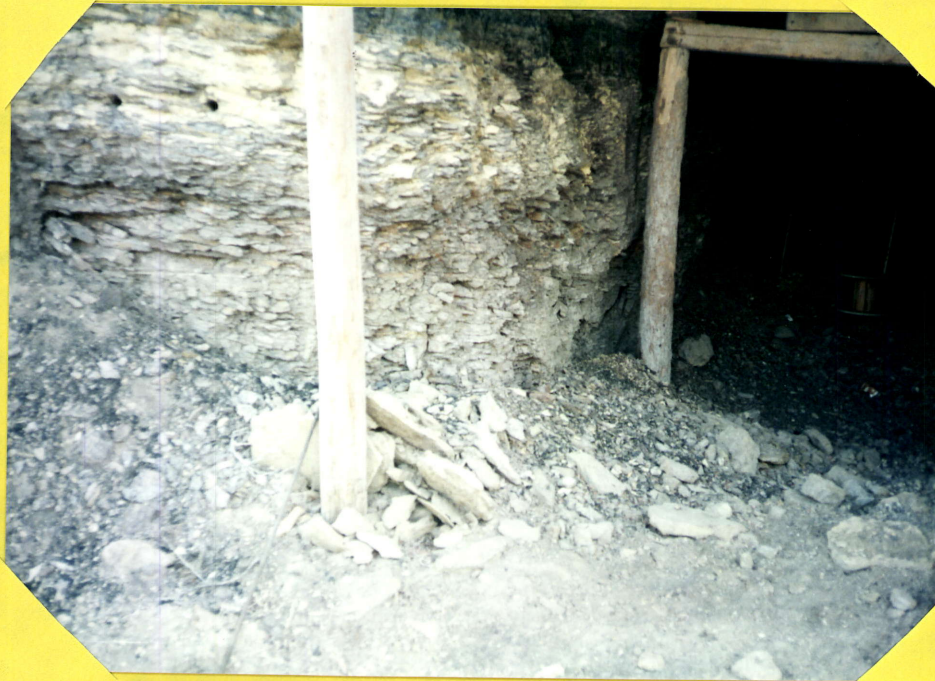
G. Rockfall on the north side of the portal, Ron Wright, notice UTU-68020 in T.21S., R.7E., Section 34. 4-16-96.

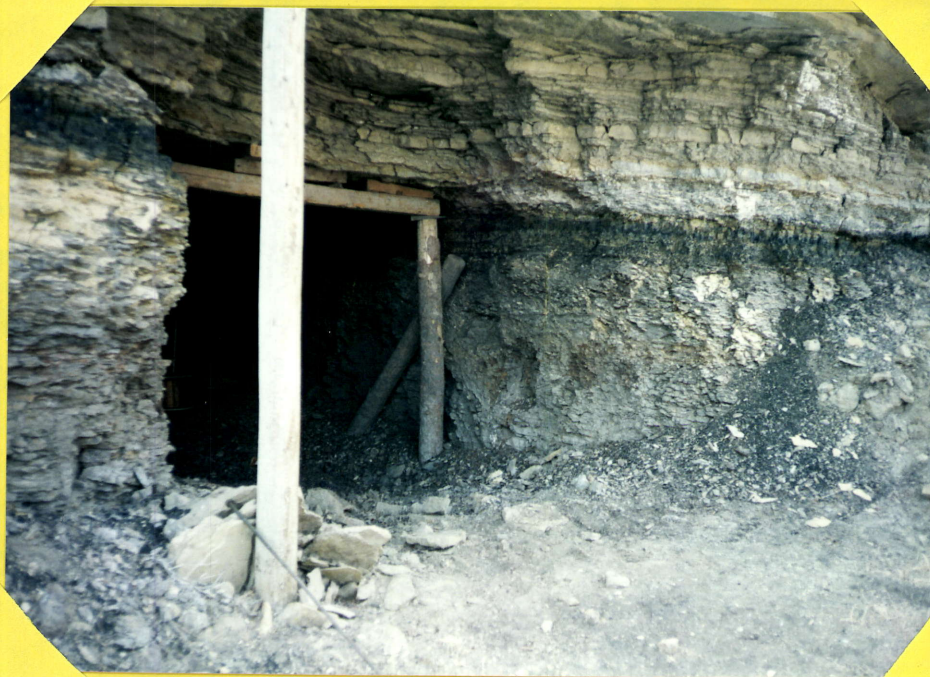
H. Fallen timber support in the Reefer mine, Ron Wright, notice UTU-68020, in T.21S., R.7E., Section 34. 4-16-96.

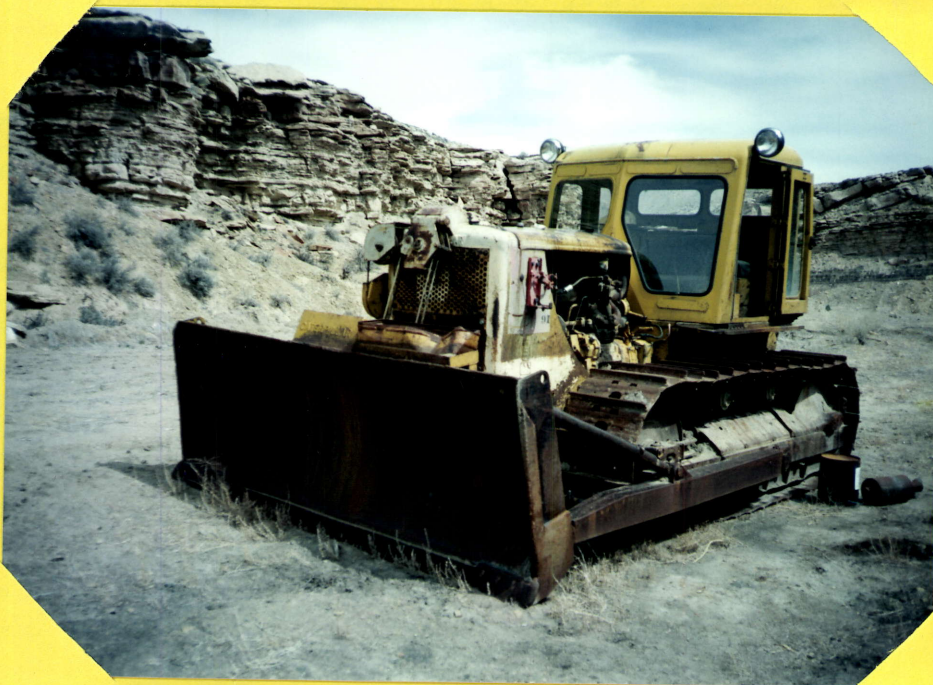
I. Rusting bulldozer located to the northwest and just outside the portal, Ron Wright, notice UTU-68020 in T.21S., R.7E., Section 34. 4-16-96.

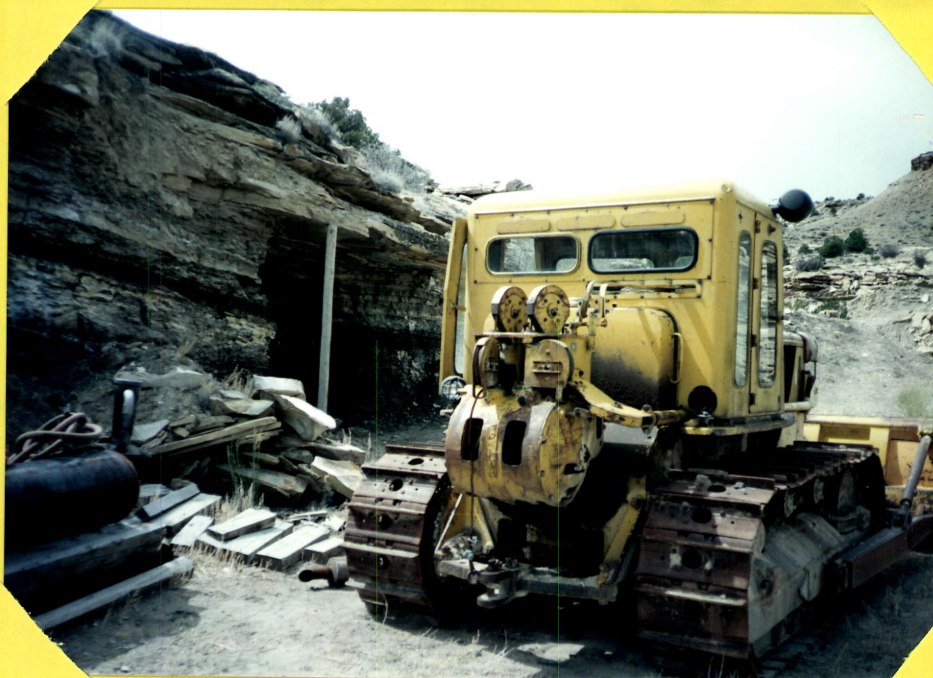
J. Rear end of the bulldozer with the portal in the background, Ron Wright, notice UTU-68020, in T.21S., R.7E., Section 34. 4-16-96.

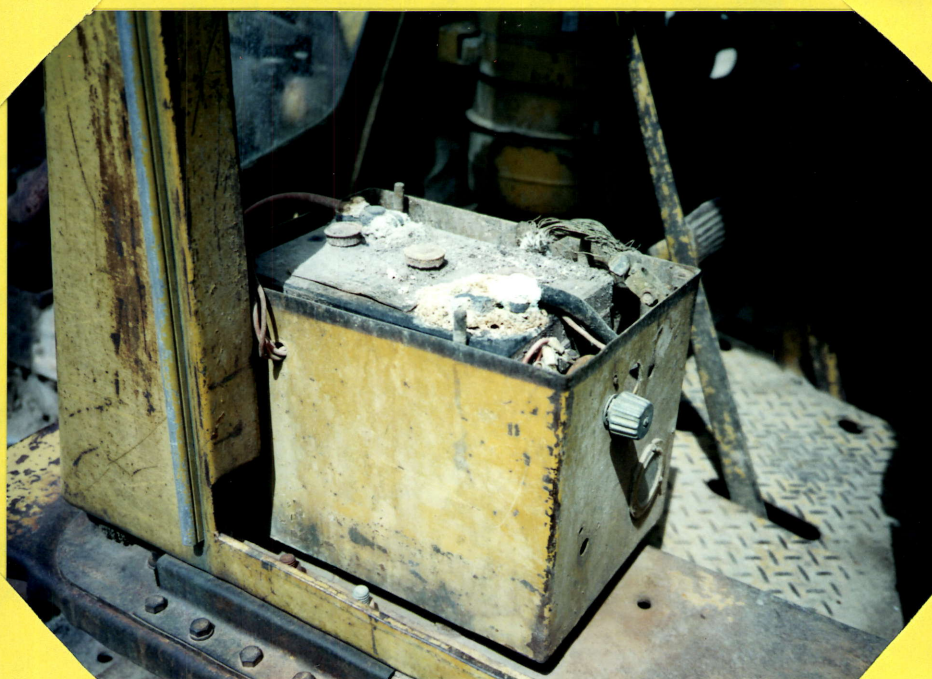
K. Corroding battery inside the bulldozer, Ron Wright, notice UTU-68020 in T.21S., R.7E., Section 34. 4-16-96.

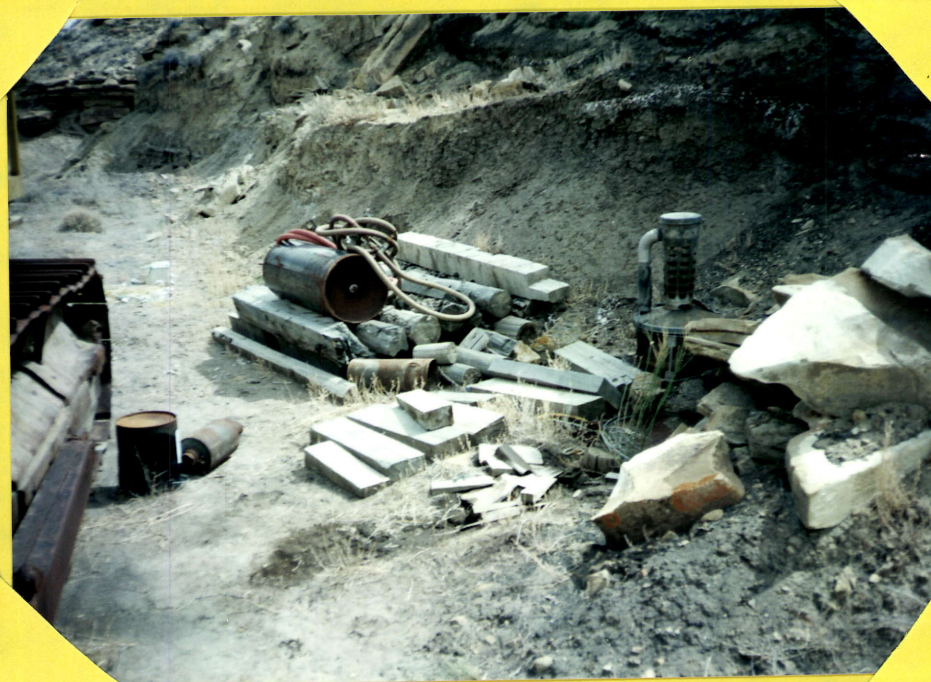
L. Lumber and miscellaneous equipment adjacent to the bulldozer, Ron Wright, notice UTU-68020 in T.21S., R.7E., Section 34. 4-16-96.

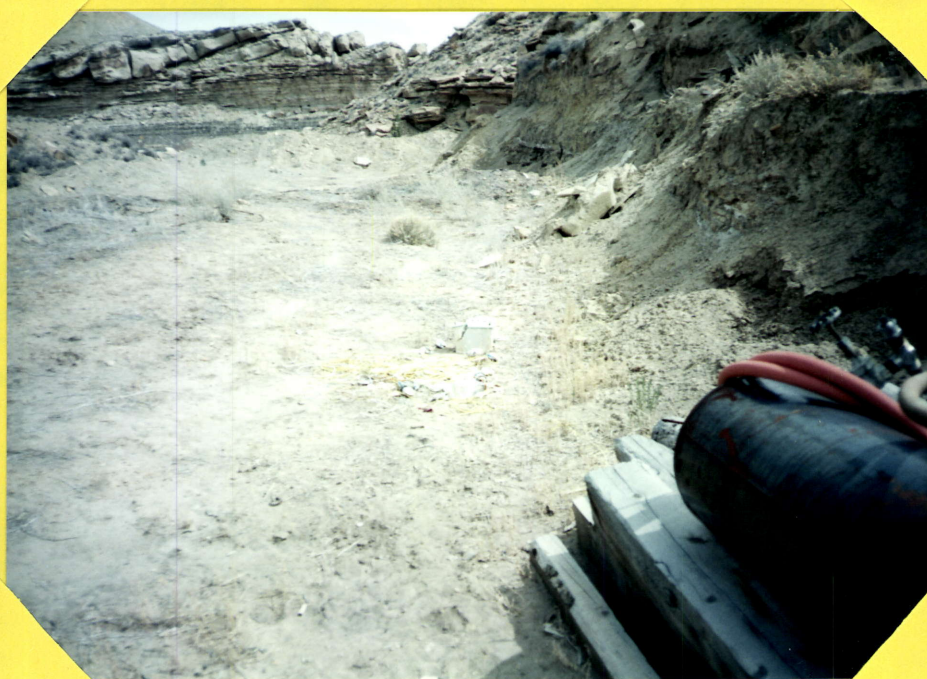
M. Broken battery located just north of the bulldozer, Ron Wright, notice 68020 in T.21S., R.7E., Section 34. 4-16196.

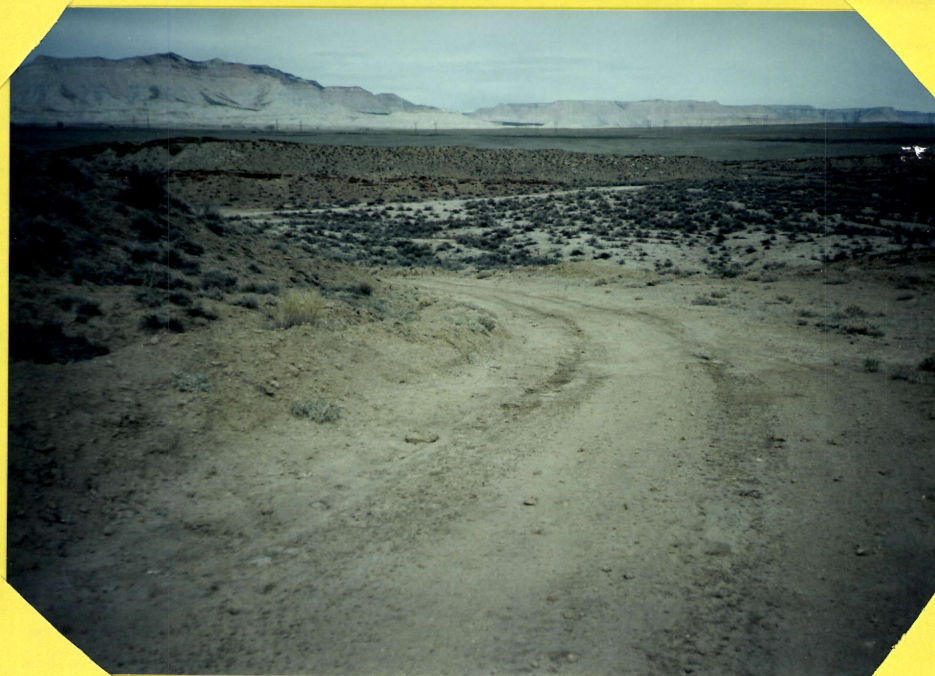
N. Looking to the west down the access road from the cliff top, Ron Wright, notice UTU-68020 in T.21S., R.7E., Section 34. 4-16-96.
